**Flood Control Project Maintenance
Levee Inspections**
LMA District Cover Sheet
Spring 2020 Levee Inspection Results

Reclamation District No. 0784 Plumas Lake

Spring 2020 Levee Inspection Results

Waterway			Bank	Unit Miles
Unit No. 01 Yuba River			Left	2.21
	Spring (March - May)	Summer (June - August)	(September - November) Fall	Winter (December - February)
Unit Maintenance Rating (Fall Only)				
Date of Inspection	3/9/2020 - 3/9/2020			
DWR Inspector	Sterling York			
Accompanied By	Patrick Meagher RD 784

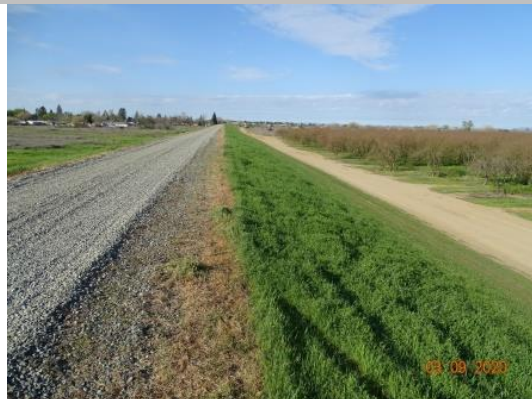
Photo 1 of 1 : SP_2020_RD0784_178_3_20200310_00005.jpg

View looking downstream waterside at the well maintained annual vegetation, Spring 2020.

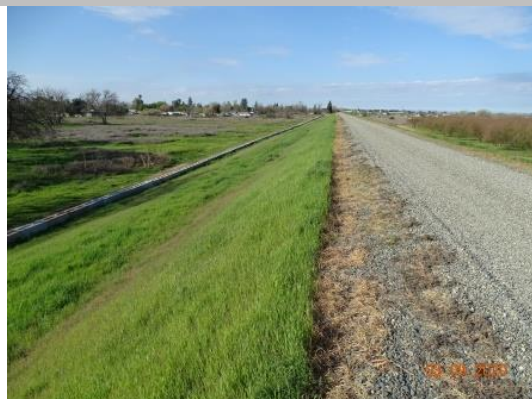
Photo 1 of 1 : SP_2020_RD0784_178_2_20200310_00006.jpg

LM Start	0.04	Rating **	A	Issue No.	2
LM End	2.21	Issue Type +	Ma	Location *	LS
Category	Earthen Levee			GPS Latitude/Longitude	
				Start	End
Item	Vegetation			39.134404 °	39.125840 °
				-121.552729 °	-121.588659 °
DWR ID	DWR_RD0784_01_s _ 2020_2				
Comment Code					
V1 : Control annual grass and weeds on the levee slopes and easements.					
Inspector Comment					
The annual vegetation is well maintained, Spring 2020.

View looking downstream landside at the well maintained annual vegetation, Spring 2020.

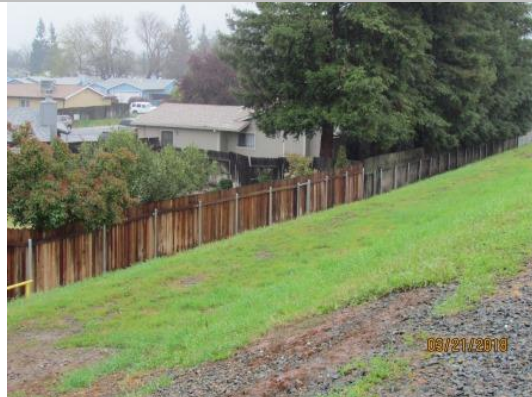
Photo 1 of 1 : SP_2020_RD0784_178_12_20200227_00001.jpg

LM Start	0.51	Rating **	U	Issue No.	12
LM End	1.00	Issue Type +	En	Location *	LS
Category	Earthen Levee			GPS Latitude/Longitude	
				Start	End
Item	Encroachments			39.131558 °	39.129475 °
				-121.560668 °	-121.569209 °
DWR ID	DWR_RD0784_01_f_2012_12				
Comment Code					
FE : Fence					
Inspector Comment					
Fences are found within the 10 feet of levee easement.

View looking downstream landside of fences that are found on the landside toe of the levee looking downstream.

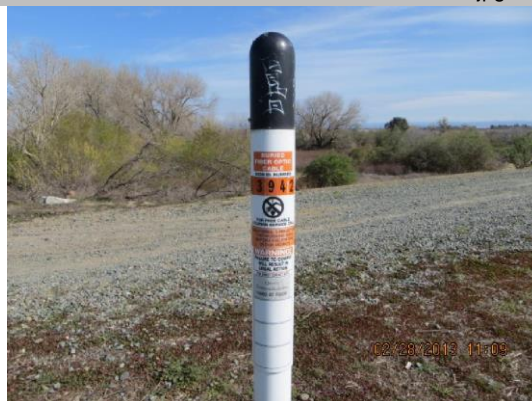
Photo 1 of 3 : UCIP_SP_2020_50677_54402.jpg

Comment Code						
Inspector Comment						
DS_ID:18552 FS_ID:50677 EP_NO: N/A Repair Type: Non-Urgent Crossing Status: Indicator Found UCIP Comments: 11/15/2016 - Crossing is still Non-Urgent due to the possibility that the pipe is unpermitted. The crossing will be downgraded when owner provides permit or CVFPB enforcement resolves the issue. (DWR UCIP - thatch)11/01/2015 - Letter requesting permit or to provide permit sent to owner Century Link, 700 W. Mineral Avenue, Rm D 27.34, Littleton, CO 80120 on 2/18/2014. Pending CVFPB enforcement on utility crossing owner. Requesting DWR inspector to change the status of this issue to "No Action Needed" (P. Meagher - RD784) 02/28/2013 - No permit identified for this crossing. Need to determine if owner has permit. (W.Wylie UCIP Inspector). FIELD_STRUCT_DESC: Fiber optics communications lines of an unknown material and diameter through the levee, at an unknown depth. [Additional Reference(s): DWR Levee Log, 2005]. FS Date: 9/11/2015 9:08:00 AM

Marker on east side of Rail/WS of Levee.

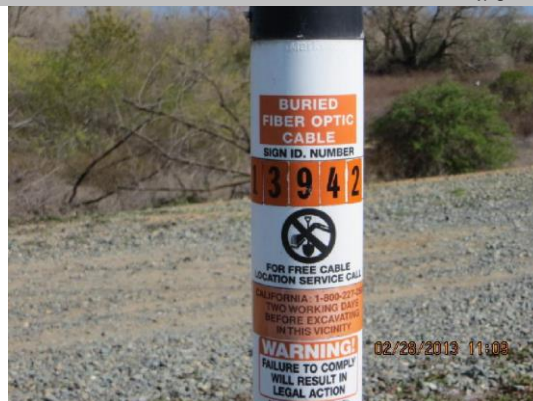
Photo 2 of 3 : UCIP_SP_2020_50677_54401.jpg

Marker on east side of Rail/WS of Levee.

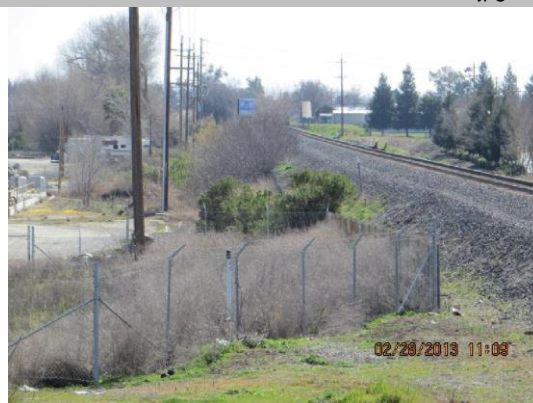
Photo 3 of 3 : UCIP_SP_2020_50677_54400.jpg

Marker on East side of Rail/LS of levee.

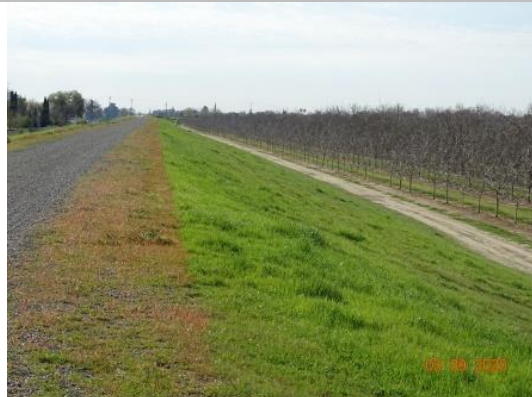
Photo 1 of 1 : SP_2020_RD0784_531_1_20200310_00001.jpg

View looking downstream waterside at the well maintained annual vegetation, Spring 2020.

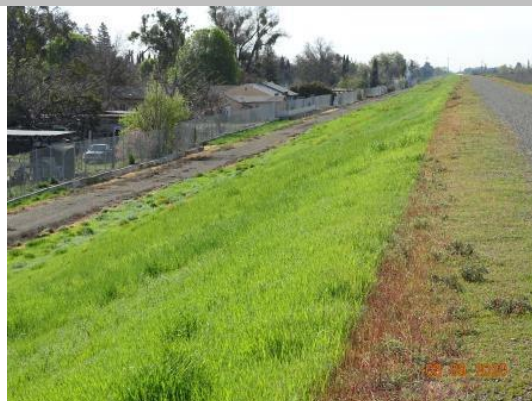
Photo 1 of 1 : SP_2020_RD0784_531_2_20200310_00002.jpg

LM Start	0.00	Rating **	A	Issue No.	2
LM End	2.54	Issue Type +	Ma	Location *	LS
Category	Earthen Levee			GPS Latitude/Longitude	
				Start	End
Item	Vegetation			39.125841 °	39.090345 °
				-121.588659 °	-121.584731 °
DWR ID	DWR_RD0784_02A_s _ 2020_2				
Comment Code					
V1 : Control annual grass and weeds on the levee slopes and easements.					
Inspector Comment					
The annual vegetation is well maintained, Spring 2020.

View looking downstream landside at the well maintained annual vegetation, Spring 2020.

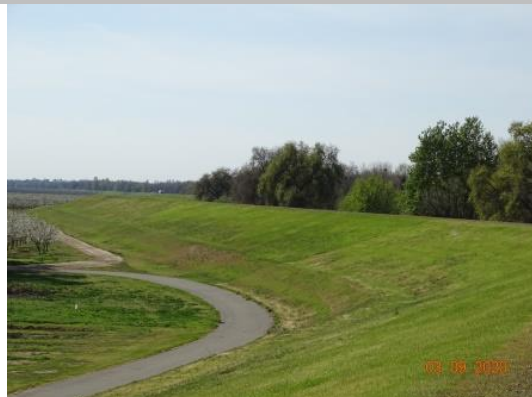
Photo 1 of 1 : SP_2020_RD0784_532_2_20200310_00004.jpg

View looking downstream landside at the well maintained annual vegetation, Spring 2020.

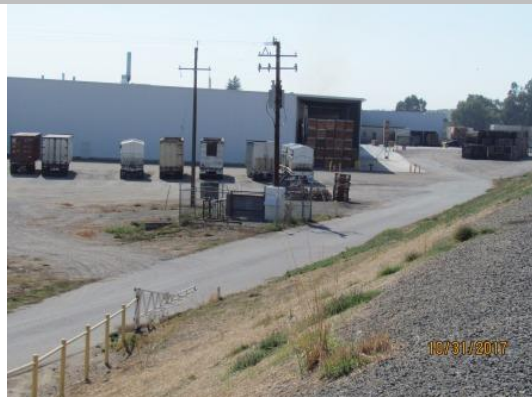
Photo 1 of 1 : SP_2020_RD0784_532_6_20200227_00002.jpg

LM Start	9.21	Rating **	M	Issue No.	6
LM End	9.31	Issue Type +	En	Location *	LS
Category	Earthen Levee			GPS Latitude/Longitude	
				Start	End
Item	Encroachments			39.006523 °	39.005235 °
				-121.577843 °	-121.578286 °
DWR ID	DWR_RD0784_02_f_2012_6				
Comment Code					
MA : Material					
Inspector Comment					
Un-permitted paving at levee toe.

View looking downstream on the landside of un-permitted paving.

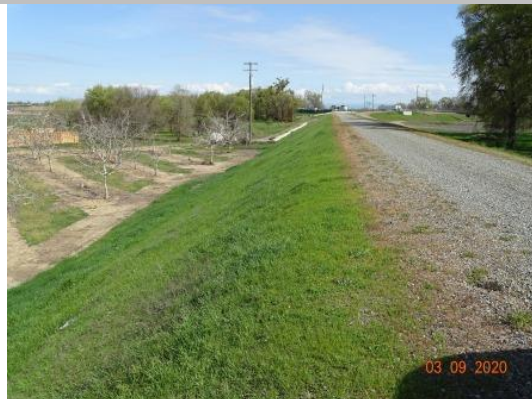
Photo 1 of 1 : SP_2020_RD0784_533_2_20200310_00001.jpg

View looking downstream landside at the well maintained annual vegetation, Spring 2020.

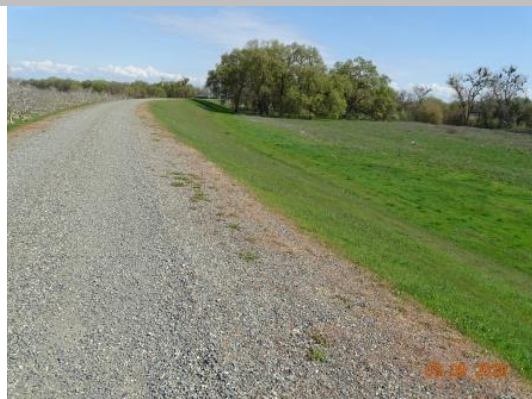
Photo 1 of 1 : SP_2020_RD0784_533_1_20200310_00002.jpg

LM Start	2.43	Rating **	A	Issue No.	1
LM End	3.19	Issue Type +	Ma	Location *	WS
Category	Earthen Levee			GPS Latitude/Longitude	
				Start	End
Item	Vegetation			38.970601 °	38.974692 °
				-121.547555 °	-121.535502 °
DWR ID	DWR_RD0784_03A_s _ 2020_1				
Comment Code					
V1 : Control annual grass and weeds on the levee slopes and easements.					
Inspector Comment					
The annual vegetation is well maintained, Spring 2020.

View looking downstream waterside at the well maintained annual vegetation, Spring 2020.

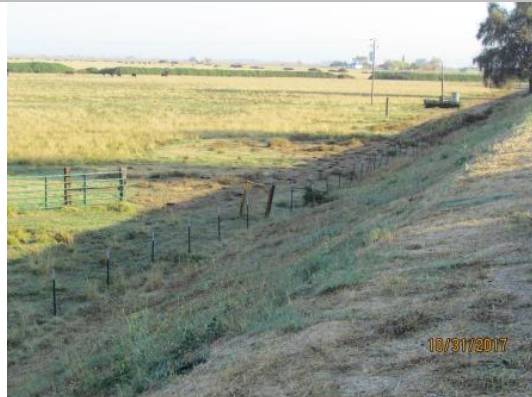
Photo 1 of 1 : SP_2020_RD0784_534_7_20200227_00001.jpg

View looking upstream landside of a fence that is at the levee toe.

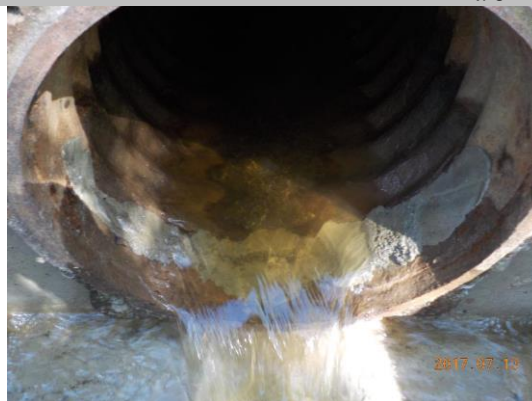
Photo 1 of 3 : UCIP_SP_2020_56110_77114.jpg

DS_ID:18627
FS_ID:56110
EP_NO: N/A
Repair Type: Urgent
Crossing Status: Found
UCIP Comments: 12/16/2019 Pipe crossing was hydroflushed and video inspected (again) in October 2019. Pending final review and recommendations from the RD784 District Engineer and DWR. (P.Meagher RD784)10/16/2018 Internal video inspection was completed recently and the inspection is being evaluated by the District Engineer. Waiting for internal inspection results to determine the internal condition of this crossing. Crossing remains Urgent due to the unknown condition of the pipe through the levee. (O. Magana - DWR UCIP)
11/30/2017 Crossing remains Urgent due to uncertainty of pipe condition through levee -- recommend an internal inspection of the pipe through the levee as a precaution measure to determine integrity of pipe. Repair of the rusted out collar (void) found at the WS pipe outlet has been repaired by the LMA. Received additional photos from DWR levee inspector, S. York, of the WS concrete headwall installed and vegetation cleared from WS. (O. Magana - DWR UCIP)

Close up photo of concrete seal where the rusted out void used to be. Farmer irrigation was currently flowing at the time the photo was taken.

07/13/2017 - The rusted out collar at the bottom of the waterside flap gate has been sealed with concrete. Internal pipe inspections still pending. (P.Meagher-RD784).
04/13/2017 - Spoke to LMA representative, P. Meagher, regarding the status of this crossing. The report has been updated to indicate vegetation has been cleared from WS outlet and LS inlet. The crossing remains Urgent--WS pipe collar is rusted out on the bottom. Recommend internal pipe inspection to determine pipe integrity through the levee. Owner will need to coordinate with the CVFPB to address issue. (O. Magana - DWR UCIP)
01/16/2017 - Landowner who utilizes this pipe reported to RD784 staff on 1/11/2017 that he suspected this pipe at the waterside flap gate ring area was rusted out at the bottom. After investigating, we could see what was reported is correct. Sandbags have been temporarily placed around the 2" +/- gapped area underneath the flap gate ring. A permanent solution is anticipated to be completed in the next 3 to 6 months. The plan is to pour a concrete ring / headwall around the open corroded pipe end. Photos attached. (P. Meagher - RD784).

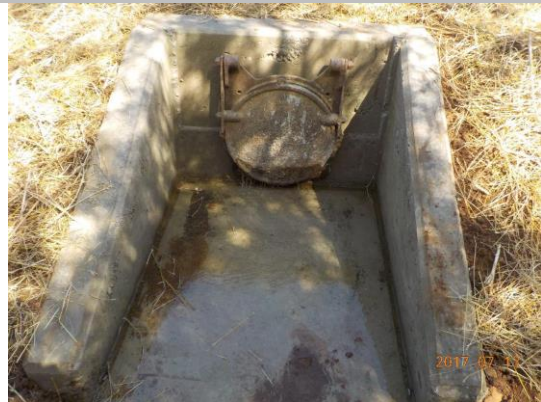
Photo 2 of 3 : UCIP_SP_2020_56110_77115.jpg

Concrete collar completed around the waterside exterior flap gate section.

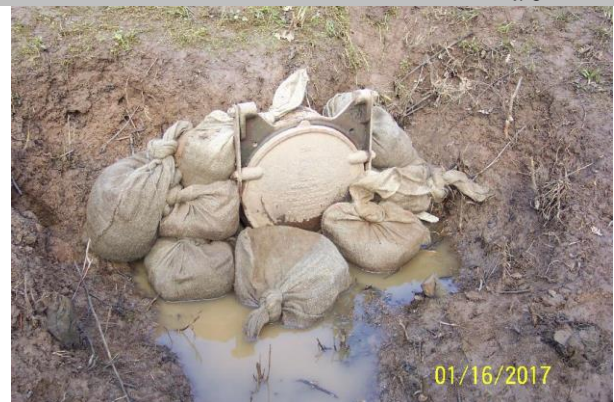
Photo 3 of 3 : UCIP_SP_2020_56110_76618.jpg

Sandbags temporarily placed in front of flapgate.

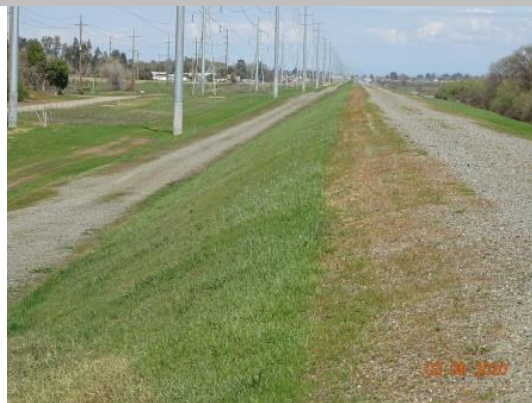
Photo 1 of 1 : SP_2020_RD0784_181_2_20200310_00007.jpg

View looking downstream landside at the well maintained annual vegetation, Spring 2020.

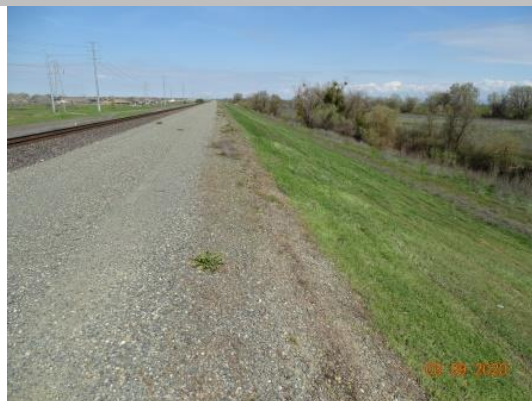
Photo 1 of 1 : SP_2020_RD0784_181_3_20200310_00006.jpg

View looking downstream waterside at the well maintained annual vegetation, Spring 2020.

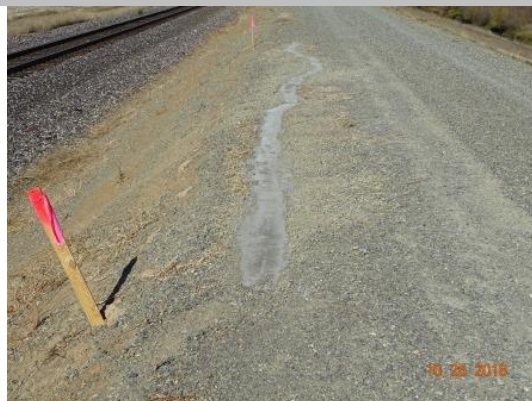
Photo 1 of 1 : SP_2020_RD0784_181_4_20200227_00001.jpg

LM Start	1.09	Rating **	A/W	Issue No.	4
LM End	1.09	Issue Type +	Ob	Location *	CR
Category	Earthen Levee			GPS Latitude/Longitude	
				Start	End
Item	Cracking			38.990383 °	38.990383 °
				-121.538051 °	-121.538051 °
DWR ID	DWR_RD0784_04_f_2018_4				
Comment Code					
CR1 : Monitor and have inspected by geotechnical engineer.					
Inspector Comment					
Lineal cracking on the crown has been repaired waiting for Engineers Report, Spring 2020.

View looking upstream on the crown of lineal cracking that has been repaired, Fall 2018.

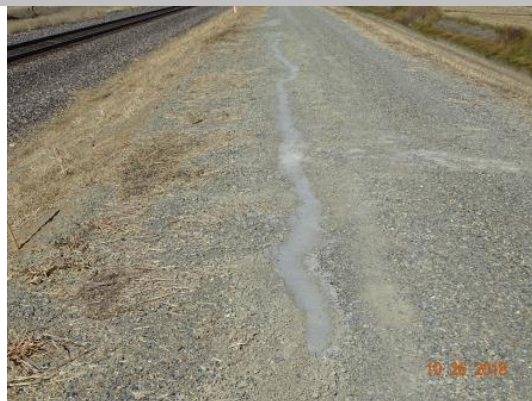
Photo 1 of 1 : SP_2020_RD0784_181_5_20200227_00002.jpg

LM Start	1.61	Rating **	A/W	Issue No.	5
LM End	1.61	Issue Type +	Ob	Location *	CR
Category	Earthen Levee			GPS Latitude/Longitude	
				Start	End
Item	Cracking			38.997839 °	38.997839 °
				-121.539477 °	-121.539477 °
DWR ID	DWR_RD0784_04_f_2018_5				
Comment Code					
CR1 : Monitor and have inspected by geotechnical engineer.					
Inspector Comment					
Lineal cracking on the crown has been repaired waiting for Engineers Report, Spring 2020.

View looking upstream on the crown of lineal cracking that has been repaired, Fall 2018.

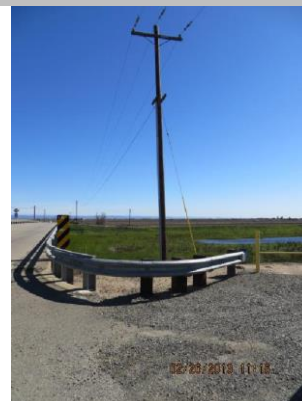
Photo 1 of 3 : UCIP_SP_2020_46600_54244.jpg

LM Start	3.59	Rating **	M	Issue No.	7	
LM End	3.59	Issue Type +	En	Location *		
Category	Supplemental			GPS Latitude/Longitude		
				Start		End
Item	DWR UCIP Field Study			39.026347 °		39.026347 °
				-121.542343 °		-121.542343 °
DWR ID	22686					
Comment Code						
Inspector Comment						
DS_ID:22686						
FS_ID:46600						
EP_NO: N/A						
Repair Type: Non-Urgent						
Crossing Status: Found						
UCIP Comments: 02/26/2013 No permit identified for crossing. (W. Wylie - DWR UCIP)						
FIELD_STRUCT_DESC: Communications cable of an unknown material and diameter through the levee, at an unknown depth, on the downstream side of the bridge. [Additional Reference(s): USACE Sacramento O&M Manual 145, August 1955, (Station 132+40), listed as an 18-inch pipe].						
FS Date: 9/11/2015 9:25:57 AM

Communication line at base of JP on WS slope.

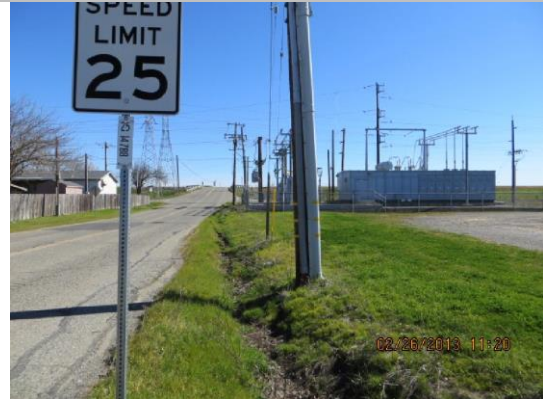
Photo 2 of 3 : UCIP_SP_2020_46600_54243.jpg

Communication line runs on south side of Plumas Arboga Road to JP approximately 400-feet West of levee crown.

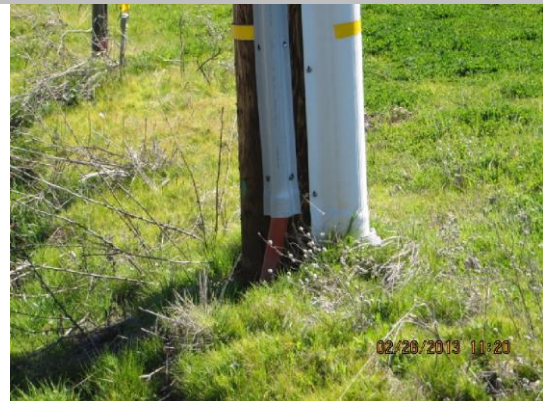
Photo 3 of 3 : UCIP_SP_2020_46600_54242.jpg

Communication line runs on south side of Plumas Arboga Road to JP approximately 400-feet West of levee crown.

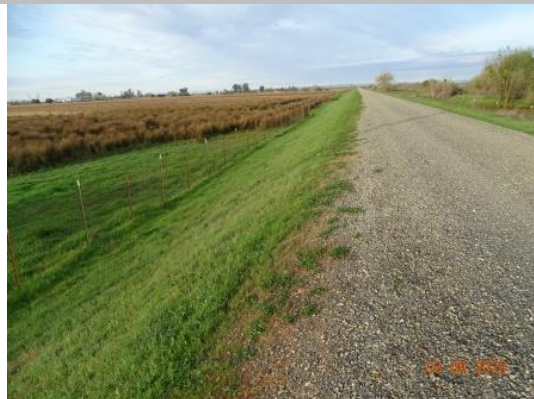
Photo 1 of 1 : SP_2020_RD0784_182_13_20200310_00029.jpg

View looking downstream landside at the well maintained annual vegetation, Spring 2020.

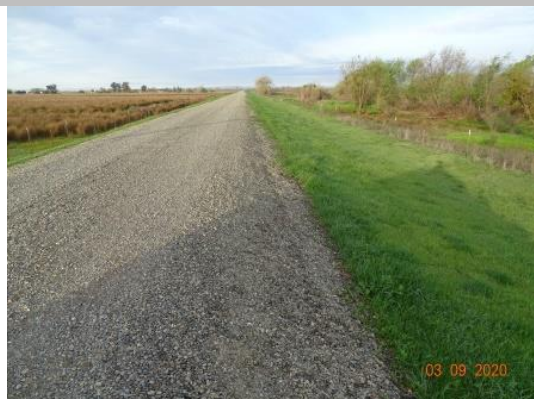
Photo 1 of 1 : SP_2020_RD0784_182_14_20200310_00030.jpg

View looking downstream waterside at the well maintained annual vegetation, Spring 2020.

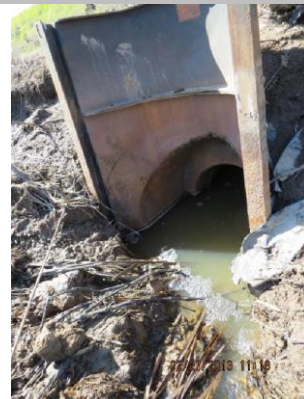
Photo 1 of 3 : UCIP_SP_2020_56118_16552.jpg

Comment Code						
Inspector Comment						
DS_ID:18592 FS_ID:56118 EP_NO: N/A Repair Type: No Action Needed Crossing Status: Found UCIP Comments: 12/16/2019 Pipe crossing was hydroflushed and video inspected (again) in October 2019. Pending final review by RD784 Engineer and DWR. 2/1/2019 - Pipe crossing was video inspected on 8/13/2018. (P. Meagher) 02/26/2013 Good candidate for video inspection. (W. Wylie - DWR UCIP) FIELD_STRUCT_DESC: 18-inch corrugated metal drainage pipe through the levee, 18 feet below the crown. Flap gate on the waterside (WS) end. Concrete U-shaped headwall on the WS end. Polyvinyl chloride weir inlet on landside (LS) toe. [Additional Reference(s): DWR Levee Log, 2005. USACE Sacramento O&M Manual 145, August 1955 (Station 25+28)]. FS Date: 2/26/2013

inlet control structure on LS toe.

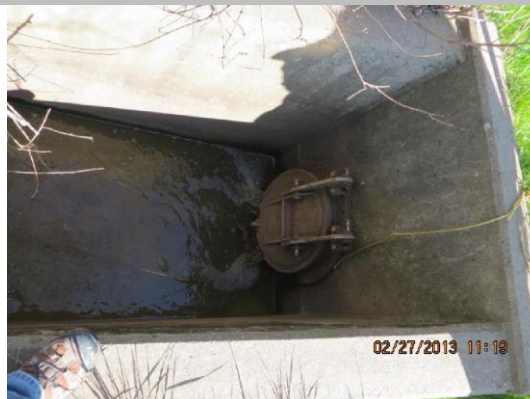
Photo 2 of 3 : UCIP_SP_2020_56118_16555.jpg

Concrete U-shaped outlet with flap gate on WS toe.

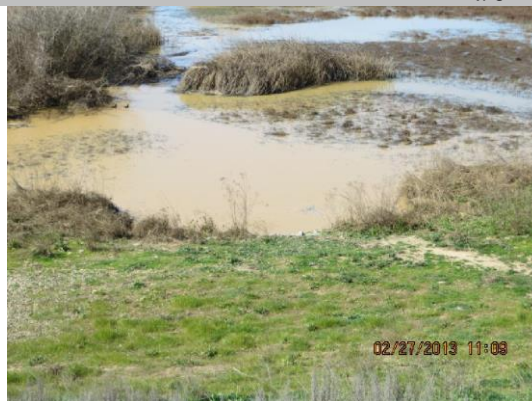
Photo 2 of 2 : UCIP_SP_2020_56112_54245.jpg

Outlet with riprap on WS toe.

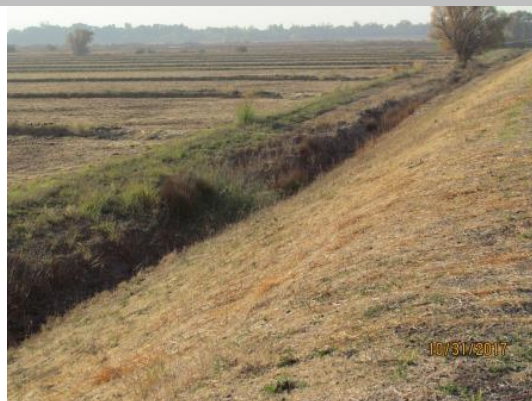
Photo 1 of 1 : SP_2020_RD0784_182_10_20200227_00003.jpg

View of landside looking downstream at the ditch that is along the levee toe.

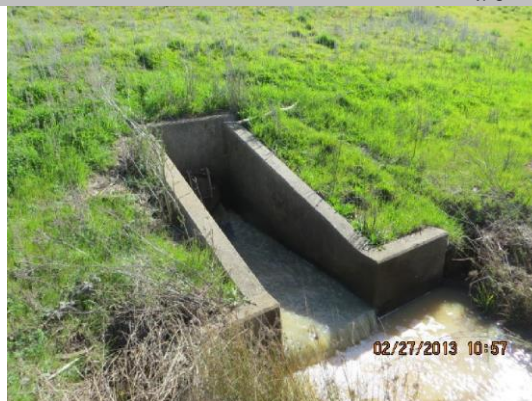
Photo 1 of 3 : UCIP_SP_2020_56119_16565.jpg

DS_ID:18590
FS_ID:56119
EP_NO: N/A
Repair Type: No Action Needed
Crossing Status: Found
UCIP Comments: 12/16/2019 Pipe crossing was hydroflushed and video inspected in October 2019. Pending final review by RD784 District Engineer and DWR. (P.Meagher - RD784)2-1-2019 - Pipe crossing was video inspected on 8/14/2018. (P. Meagher)02/26/2013 Good candidate for video inspection. (W. Wylie - DWR UCIP)
FIELD_STRUCT_DESC: 18-inch corrugated metal drainage pipe through the levee, 14.5 feet below the crown. Flap gate on the waterside (WS) end. Concrete U-shaped headwall on the WS. Polyvinyl chloride weir on inlet. (See Drawing No. 2-4-106, Sheet 5). [Additional Reference(s): DWR Levee Log, 2005. USACE Sacramento O&M Manual 145, August 1955 (Station 103+23)].
FS Date: 2/26/2013

Concrete U-shaped headwall and flap gate on WS toe.

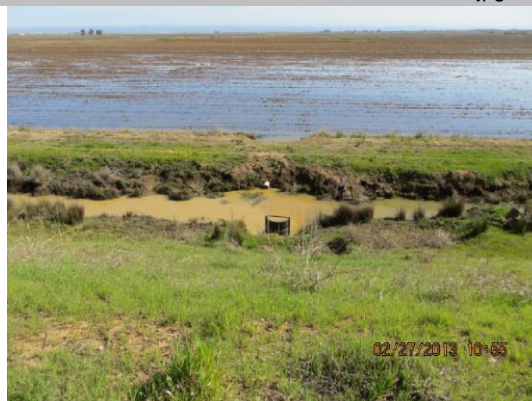
Photo 2 of 3 : UCIP_SP_2020_56119_16563.jpg

Pvc weir on inlet at LS toe.

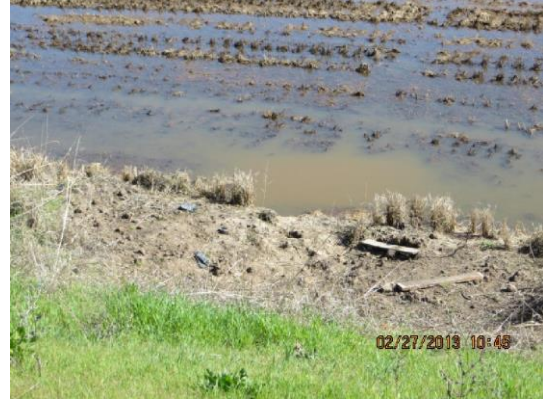
Photo 2 of 3 : UCIP_SP_2020_56113_54248.jpg

Meagher)09/11/2015 Inlet buried. Good candidate for video inspection as pipe is corroded. (G. Wylie - FPIIB)

Debris covered inlet on LS toe.

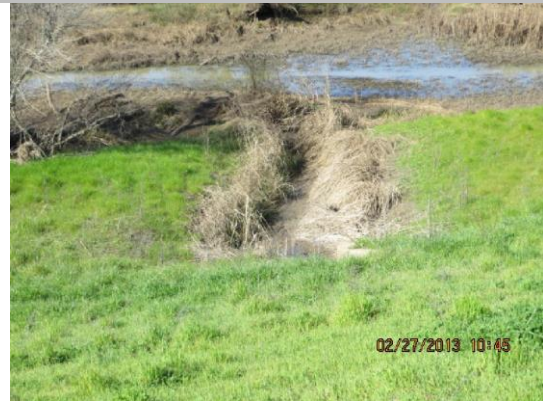
Photo 3 of 3 : UCIP_SP_2020_56113_54249.jpg

Drainage outlet on WS toe.

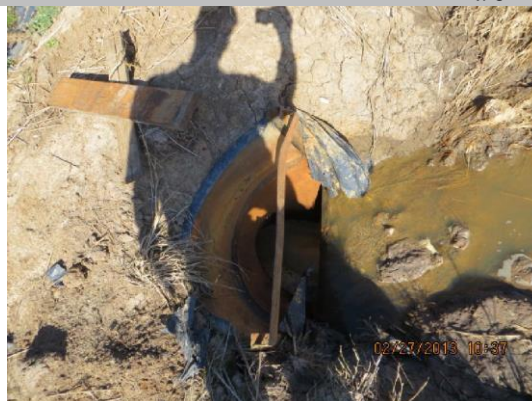
Photo 1 of 3 : UCIP_SP_2020_56111_54250.jpg

UCIP Comments: 12-16-2019 - This pipe crossing was hydroflushed and video inspected (again) in October 2019. Pending final review by RD784 District engineers and DWR. (P.Meagher - RD784)2-1-2019 - The pipe crossing was video inspected on 8/14/2018. New photos of the landside toe added. In August 2017 a sinkhole was noticed at the bottom of the landside toe shelf area. The sinkhole developed as a result of the landowner who extended the existing pipe in order to complete a new unauthorized concrete flashboard structure replacement. The pipe owner was mailed a letter from RD784 with a Cc to CVFPB and DWR dated 10/23/2017 acknowledging the owner's completion of an attempted repair. The sinkhole has since returned.

Inlet with PVC weir on LS toe.

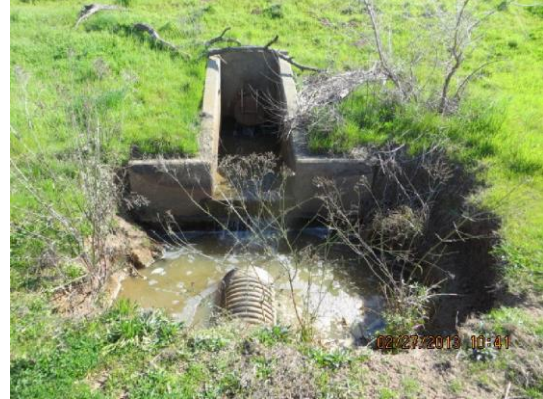
Photo 2 of 3 : UCIP_SP_2020_56111_54253.jpg

Concrete U-shaped headwall on WS toe with Flap gate showing erosion at outlet.

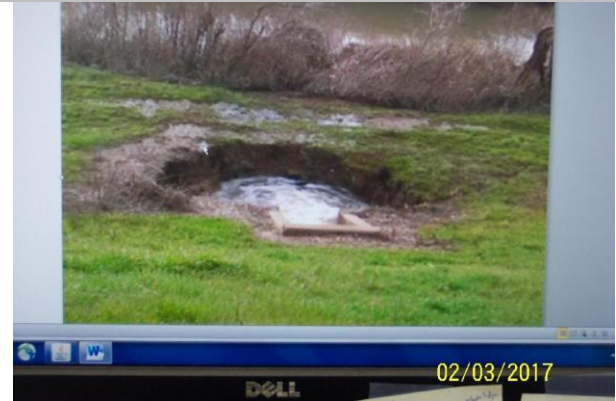
Photo 3 of 3 : UCIP_SP_2020_56111_76774.jpg

After photo after excess pipe was cut off. Actual photo date was 1/31/2017

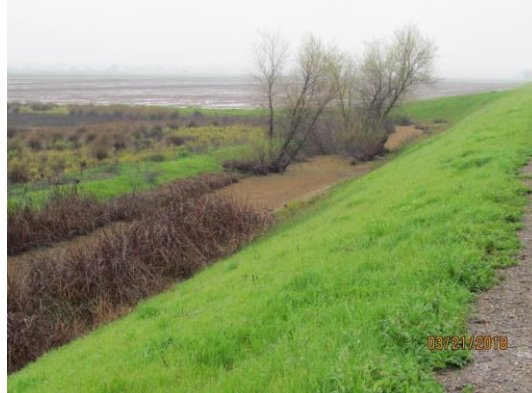
Photo 1 of 1 : SP_2020_RD0784_182_9_20200227_00002.jpg

View of landside looking downstream at the ditch that is along the levee toe.

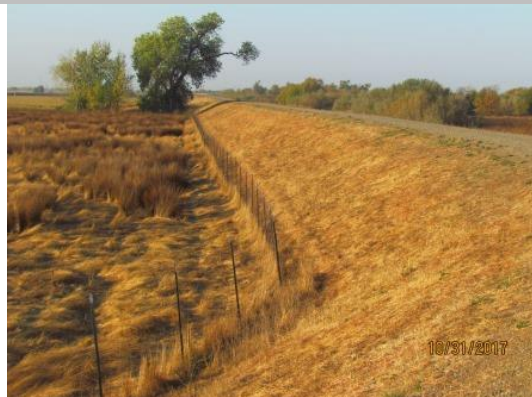
Photo 1 of 1 : SP_2020_RD0784_182_5_20200227_00001.jpg

View of fence along the landside toe looking downstream.

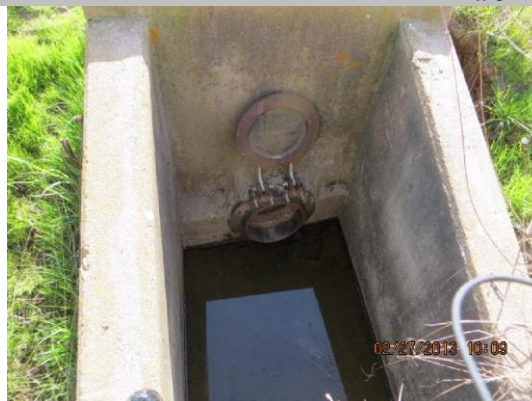
Photo 1 of 3 : UCIP_SP_2020_56114_54259.jpg

Concrete U-shaped headwall and flap gate on WS toe.

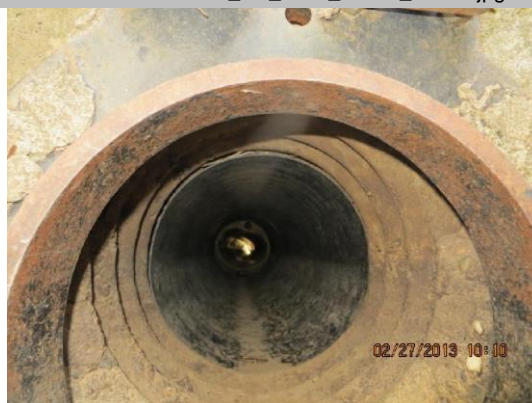
Photo 2 of 3 : UCIP_SP_2020_56114_54262.jpg

Pipe showing sliplined PVC insert. some erosion of PV at outlet and it may be disjointed internally.

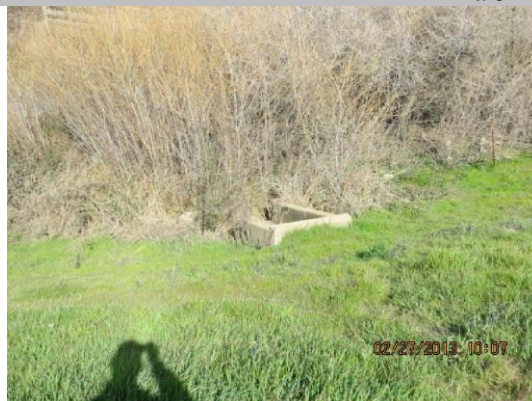
Photo 3 of 3 : UCIP_SP_2020_56114_54261.jpg

Concrete U-shaped headwall on WS toe.

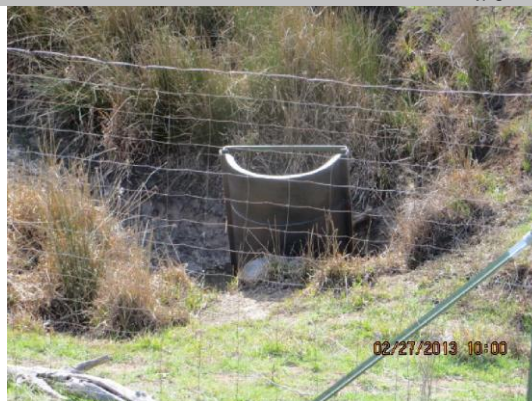
Photo 1 of 2 : UCIP_SP_2020_56115_16594.jpg

PVC weir inlet on LS toe.

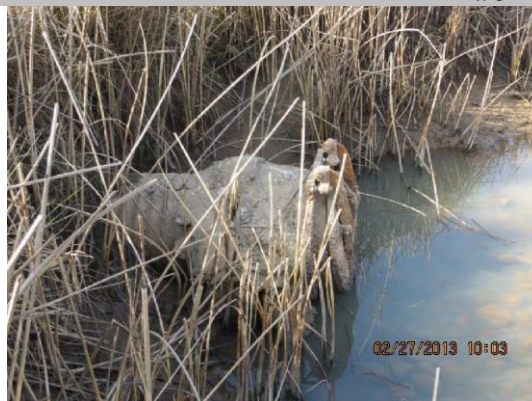
Photo 2 of 2 : UCIP_SP_2020_56115_16593.jpg

Flap gate at WS toe.

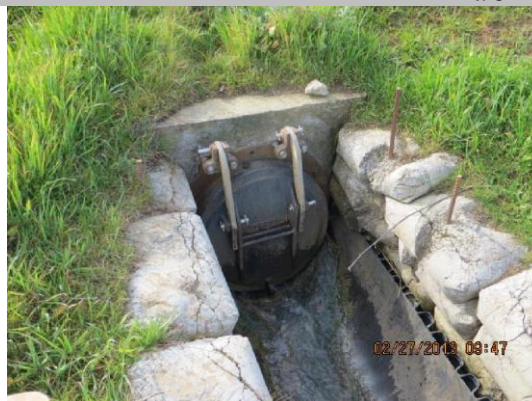
Photo 1 of 3 : UCIP_SP_2020_56117_16590.jpg

Concrete outlet and flap gate on WS toe.

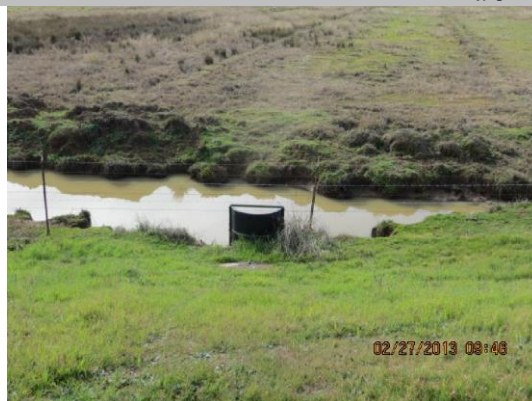
Photo 2 of 3 : UCIP_SP_2020_56117_16591.jpg

PVC weir at inlet on LS toe.

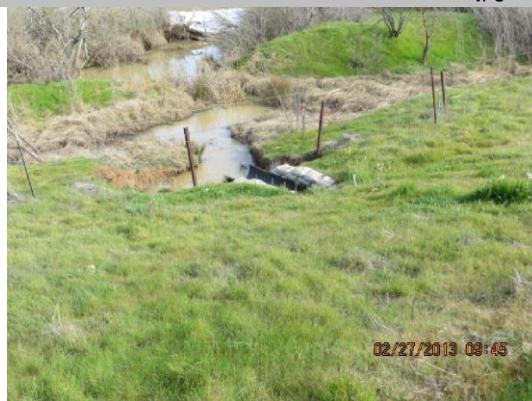
Photo 3 of 3 : UCIP_SP_2020_56117_16592.jpg

Concrete outlet on WS toe.

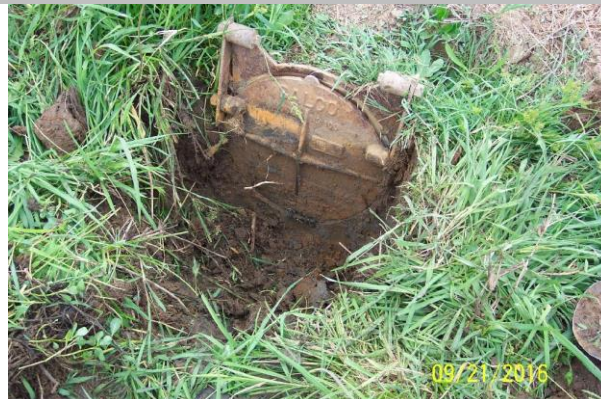
Photo 1 of 3 : UCIP_SP_2020_53550_76147.jpg

Flap gate on the WS toe is exposed

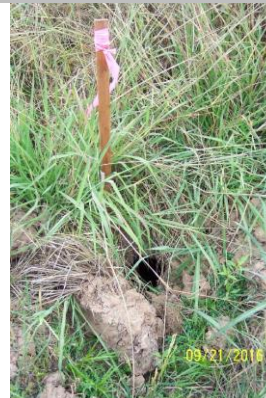
Photo 2 of 3 : UCIP_SP_2020_53550_76148.jpg

Possible location of the inlet on the LS toe

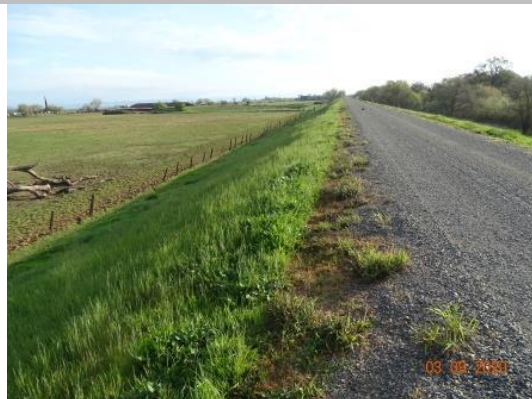
Photo 1 of 1 : SP_2020_RD0784_183_2_20200310_00005.jpg

View looking downstream landside at the well maintained annual vegetation, Spring 2020.

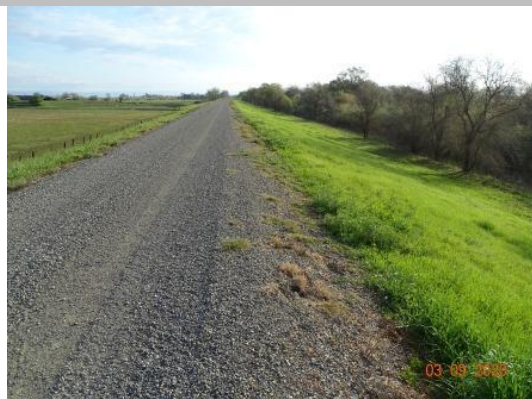
Photo 1 of 1 : SP_2020_RD0784_183_3_20200310_00004.jpg

View looking downstream waterside at the well maintained annual vegetation, Spring 2020.

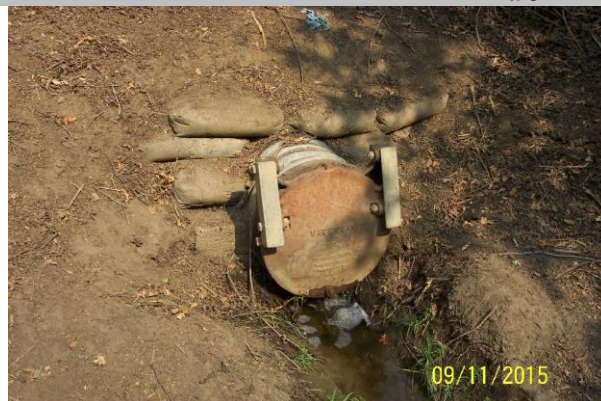
Photo 1 of 3 : UCIP_SP_2020_56120_74682.jpg

Flap Gate is clear as of 9/11/15.

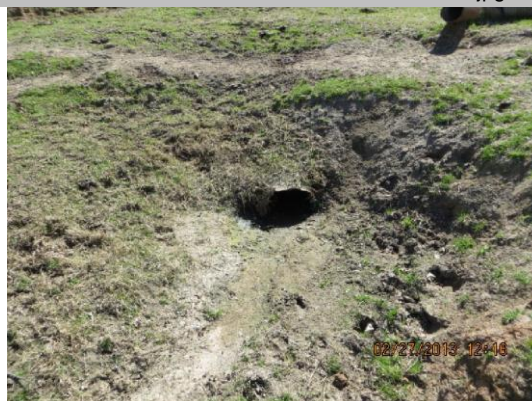
Photo 2 of 3 : UCIP_SP_2020_56120_54268.jpg

Partially clogged inlet pipe at LS toe.

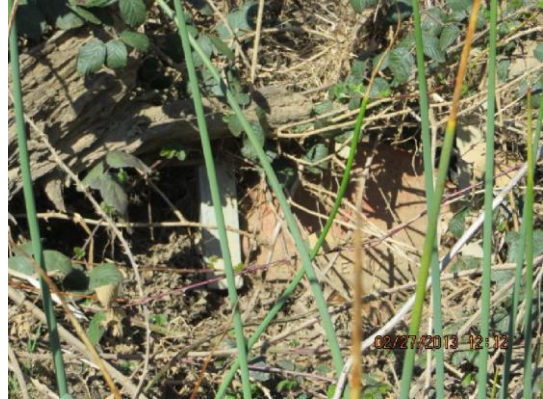
Photo 3 of 3 : UCIP_SP_2020_56120_54265.jpg

Flap gate blocked by vegetation at WS.

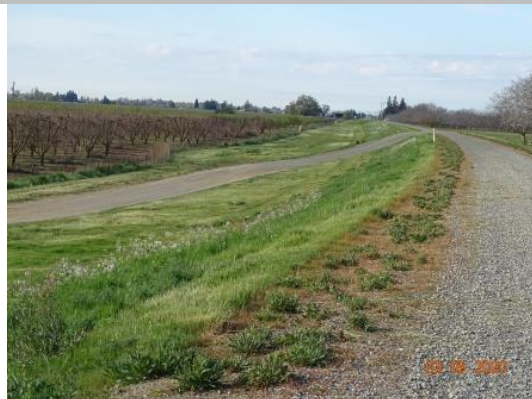
Photo 1 of 1 : SP_2020_RD0784_184_1_20200310_00002.jpg

View looking downstream landside at the well maintained annual vegetation, Spring 2020.

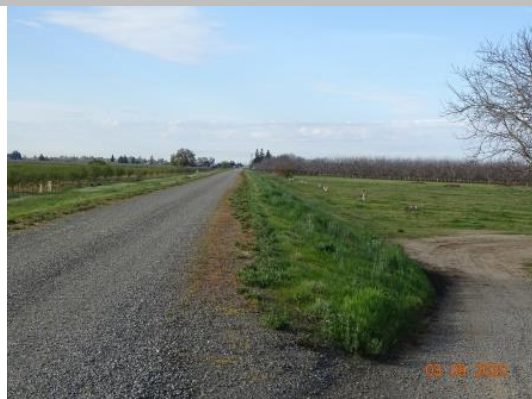
Photo 1 of 1 : SP_2020_RD0784_184_2_20200310_00001.jpg

View looking downstream waterside at the well maintained annual vegetation, Spring 2020.

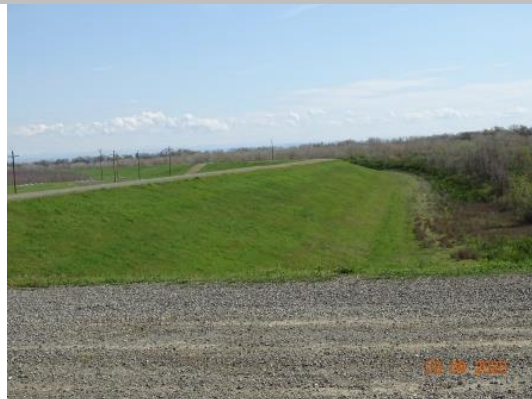
Photo 1 of 1 : SP_2020_RD0784_437_2_20200310_00002.jpg

View looking downstream waterside at the well maintained annual vegetation, Spring 2020.

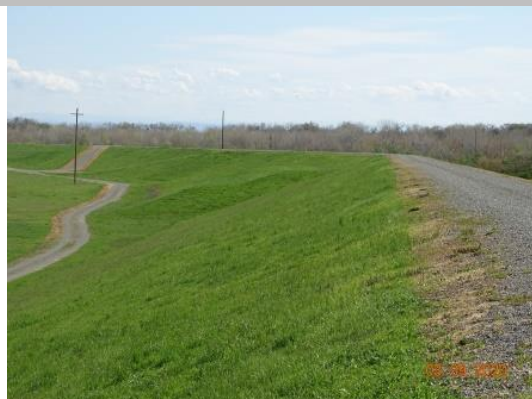
Photo 1 of 1 : SP_2020_RD0784_437_1_20200310_00003.jpg

View looking downstream landside at the well maintained annual vegetation, Spring 2020.

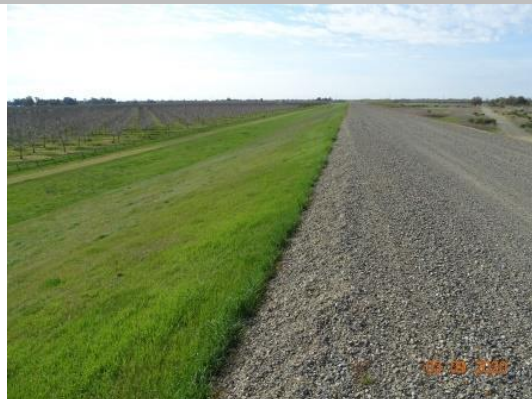
Photo 1 of 1 : SP_2020_RD0784_530_1_20200310_00001.jpg

View looking downstream landside at the well maintained annual vegetation, Spring 2020.

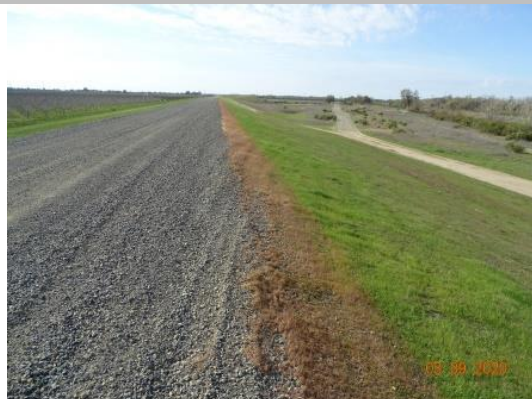
Photo 1 of 1 : SP_2020_RD0784_530_2_20200310_00002.jpg

View looking downstream waterside at the well maintained annual vegetation, Spring 2020.
